Jam in Ingoing Drive Gear

This support article is to help if you see that filament has gotten jammed in the gears of Palette's ingoing drives.

Written By: Mosaic Support

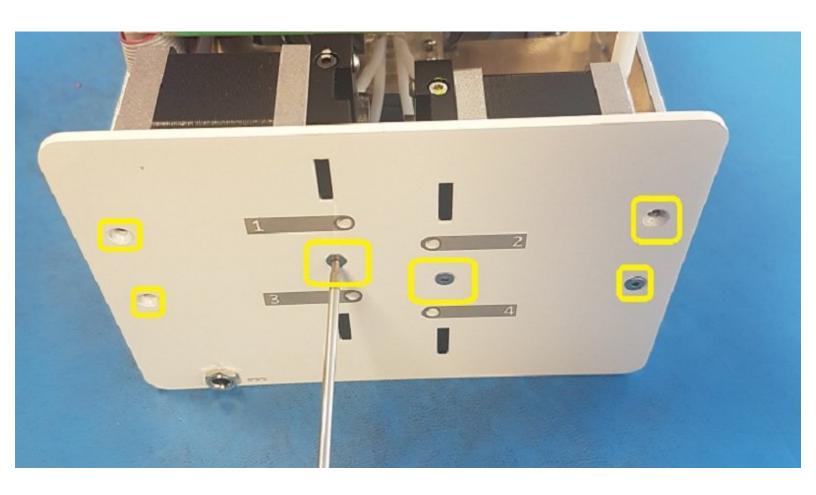
This support article is to help if you see that filament has gotten jammed in the gears of Palette's ingoing drives. This can be caused by sharp filament being loaded into Palette which gets caught before entering the Teflon tubing.
